Home Inspection Report For Sample Sample 12345 Sample Street, Sample City, IL 55555

Kollias Property Inspections Inc

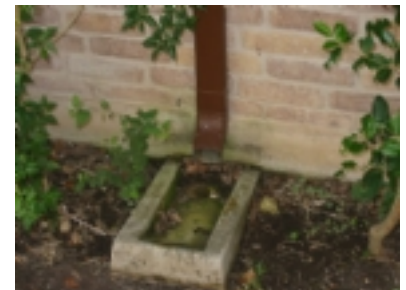
Downspouts:

REPAIR or REPLACE - The downspout discharge drains close to the house. As a rule of thumb, a minimum drainage of six feet from the house is recommended. In my opinion when drainage is closer than 6 feet there is an increased potential for water to go back to the foundation and result in water leakage into basements and crawl spaces. Water leakage can cause various problems and damage including damaging drywall, plaster, paneling, flooring and similar. Water leakage can also lead to mold problems. I recommend that you contact a qualified contractor to mitigate the situation if possible.

REPAIR or REPLACE - The downspout discharge drains close to the house. As a rule of thumb, a minimum drainage of six feet from the house is recommended. In my opinion when drainage is closer than 6 feet there is an increased potential for water to go back to the foundation and result in water leakage into basements and crawl spaces. Water leakage can cause various problems and damage including damaging drywall, plaster, paneling, flooring and similar. Water leakage can also lead to mold problems. I recommend that you contact a qualified contractor to mitigate the situation if possible.

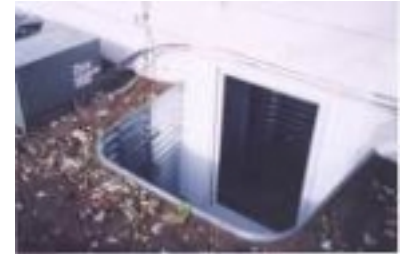
Window Wells:

SAFETY - The window wells do not have any covers on them. In my opinion, this is a fall-in injury hazard. Additionally, certain covers help to keep water out and reduce leakage potential. I recommend that you contact a qualified contractor to install sturdy window well covers.

SAFETY - The window wells do not have any covers on them. In my opinion, this is a fall-in injury hazard. Additionally, certain covers help to keep water out and reduce leakage potential. I recommend that you contact a qualified contractor to install sturdy window well covers.

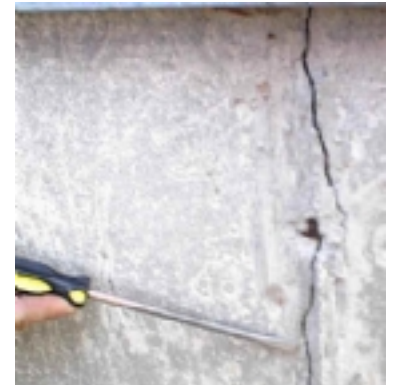
Foundation:

REPAIR or REPLACE - One or more cracks are present in the foundation wall. In my opinion cracks can be found in most foundations. However, it can allow for water leakage. Water leakage can cause various problems and damage including damaging drywall, plaster, paneling, flooring and similar. Water leakage can also lead to mold problems. Additional evaluation and appropriate corrective action by a qualified contractor is recommended.

REPAIR or REPLACE - One or more cracks are present in the foundation wall. In my opinion cracks can be found in most foundations. However, it can allow for water leakage. Water leakage can cause various problems and damage including damaging drywall, plaster, paneling, flooring and similar. Water leakage can also lead to mold problems. Additional evaluation and appropriate corrective action by a qualified contractor is recommended.
